### 10.9.3 Effects of Temperature Loading on Member Overload

#### 10.9.4 Failures Caused by Incorrect Design

#### 10.9.5 Failures of Purlins and Girts

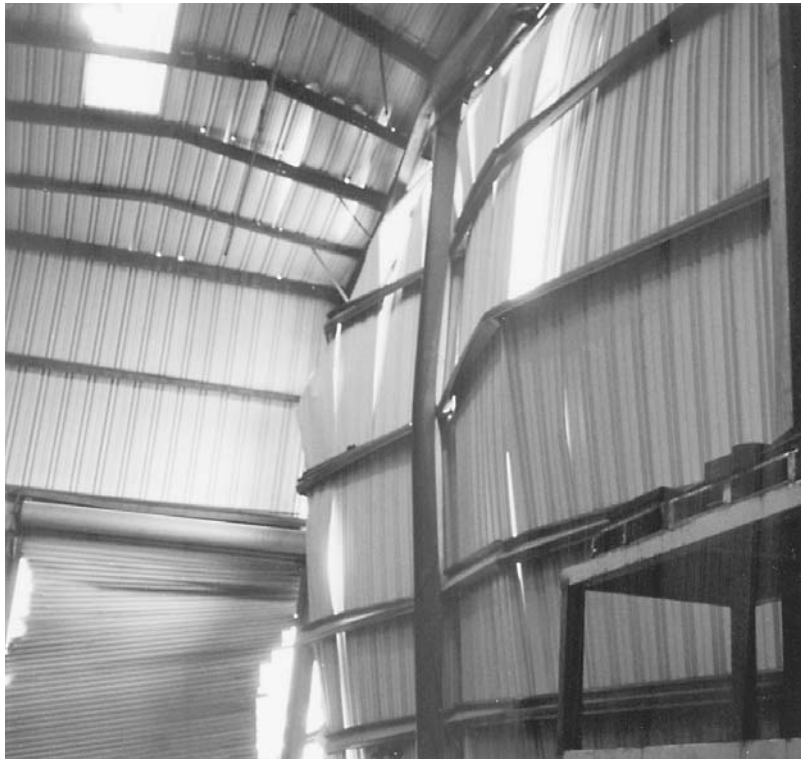
Figure 10.17 illustrates building damage caused by local wind overload. The investigators have traced it to a microburst—a small-scale but severe wind downdraft. Microbursts have been blamed for many aircraft crashes during takeoffs and landings. Note that the endwall girts and columns, as well as the roof purlins in the first exterior bay, have buckled—and that the purlins have buckled upward. The overhead door has failed as well, quite consistent with our discussion in Sec. 10.4.

**FIGURE 10.17** This building in Southern California partly failed under wind loading. Note buckling of endwall girts and roof purlins and failure of overhead door. (Photo: J.R. Miller & Associates.)
