10.9.9 Failures Caused by Deterioration

10.9.10 Other Causes of Failure

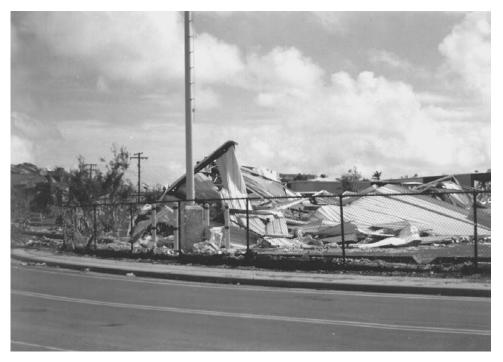
FIGURE 10.20 Total collapse of a metal building. (Photo: Structural Engineers Association of Hawaii.)

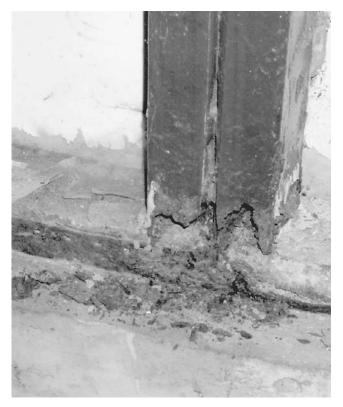
Corrosion can result from roof leaks, condensation, and even groundwater entry. In one oceanfront industrial pre-engineered building of early vintage, the author found the bases of loadbearing

Downloaded from Digital Engineering Library @ McGraw-Hill (www.digitalengineeringlibrary.com) Copyright © 2004 The McGraw-Hill Companies. All rights reserved. Any use is subject to the Terms of Use as given at the website. wall studs supporting light-gage trusses completely rusted (Fig. 10.21). The deterioration was determined to be the result of repeated flooding during several storms and hurricanes that took place during the long life of the building. The integrity of the steel was virtually nonexistent—to the point that the wall siding probably carried the building weight!

FIGURE 10.21 Bases of cold-formed wall studs supporting trusses in this early-vintage pre-engineered building are completely corroded from repeated saltwater entry.
