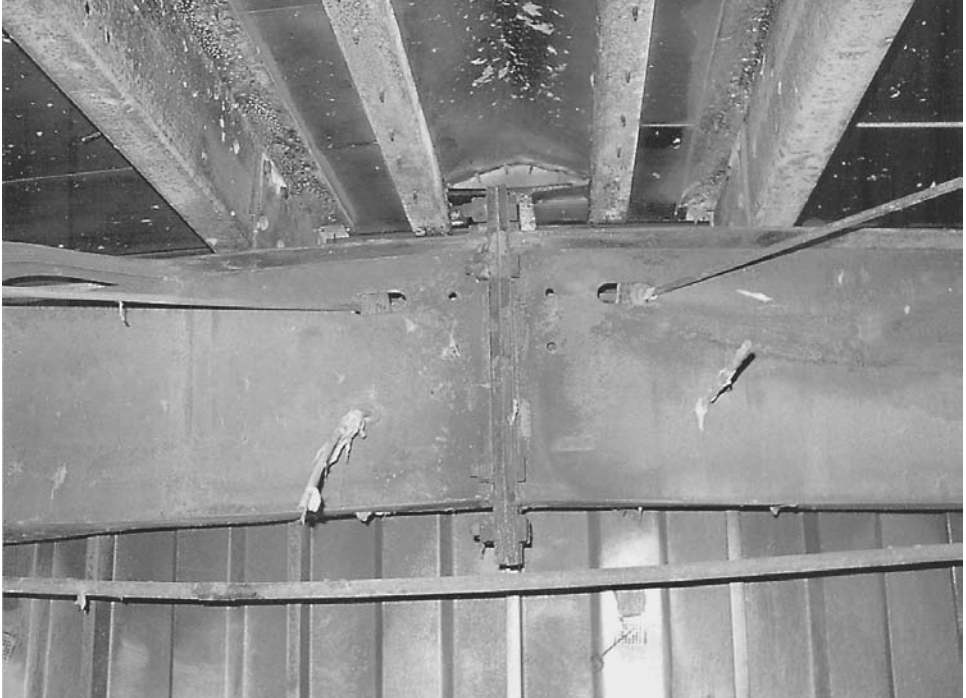
FIGURE 10.22 Effects of small fire on metal building system. The area at left is amplified in Fig. 10.23. Note also the method of rod attachment to frame. (Photo: Chabot Engineering.)

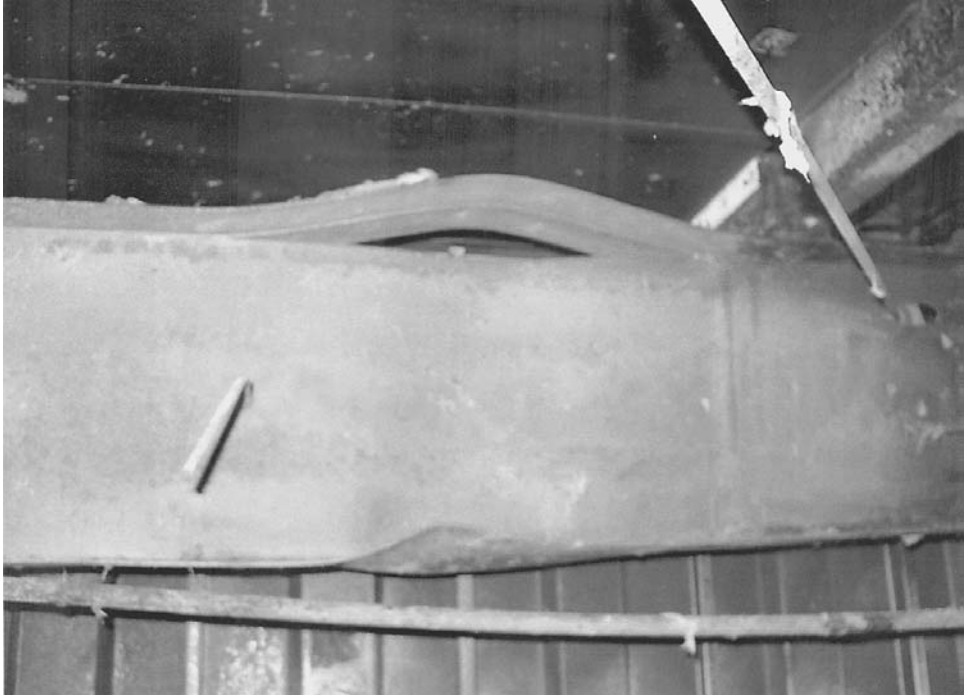
FIGURE 10.23 Fire-damaged primary frame. (Photo: Chabot Engineering.)

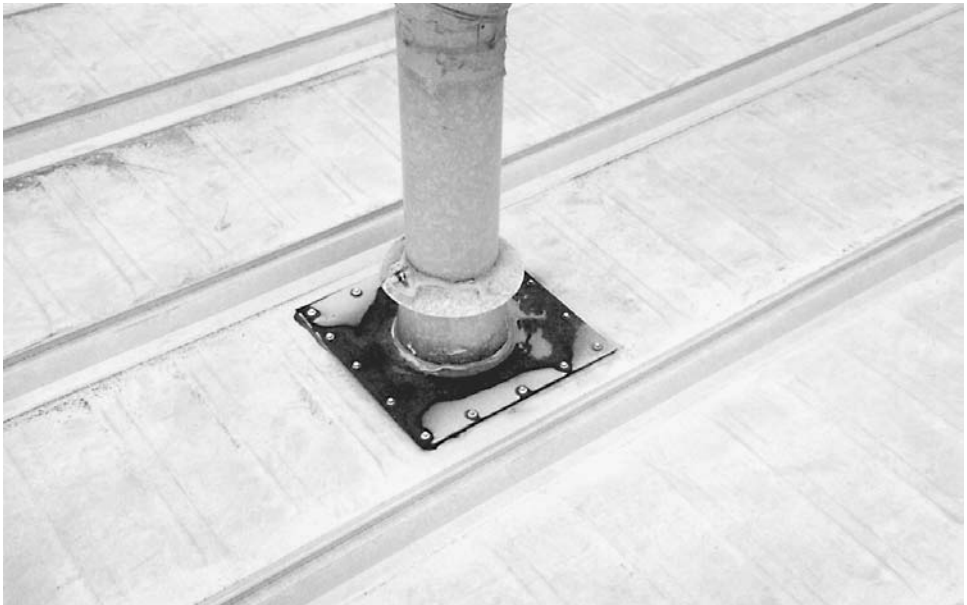
FIGURE 10.24 Damaged pipe boot flashing allows water to enter the building.
