## 8.5 HOW TO MAXIMIZE THERMAL PERFORMANCE

### 8.5.1 Avoiding Condensation

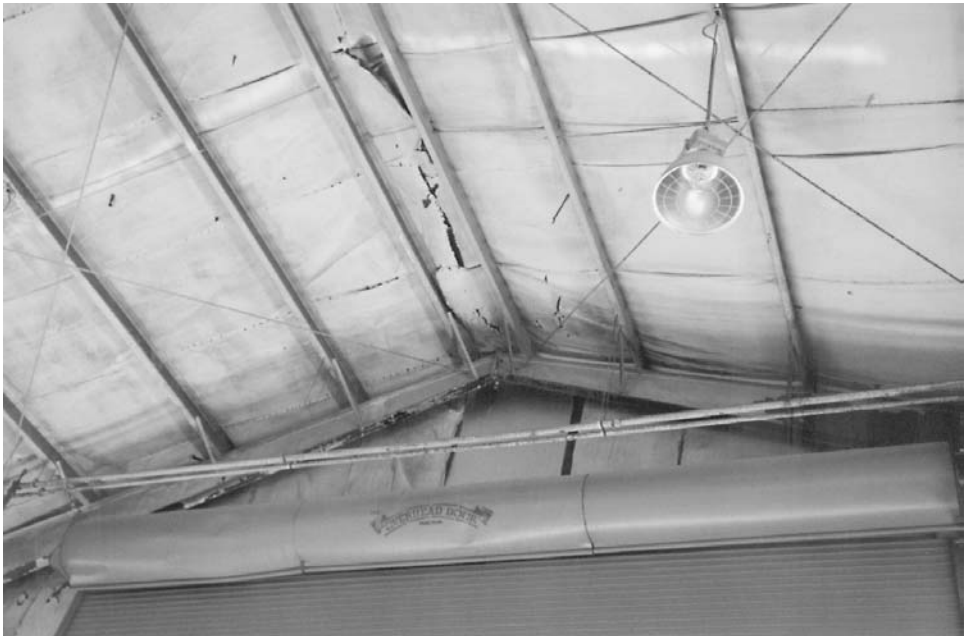
FIGURE 8.2 Cracked and torn vinyl vapor retarder.

Pure-vinyl vapor retarders were used almost exclusively earlier, but vinyl usage is declining. Despite its low cost, vinyl has very high permeance, low puncture resistance, and a tendency to yellow and crack with age (Fig. 8.2). Any of the new materials can do the job much better. If the price is the only criterion, nonmetallized polypropylene/scrim/kraft facing, often marketed as a replacement for vinyl, is among the cheapest white reinforced facings available. However, its high perm rating (0.09 or so) is 4.5 times larger than that of the metallized version, which is still moderately priced.
