## 10.8 SPECIFYING EXPOSED FRAMING

## 10.9 FAILURES OF PRE-ENGINEERED BUILDINGS

### 10.9.1 Main Causes of Metal Building Failures

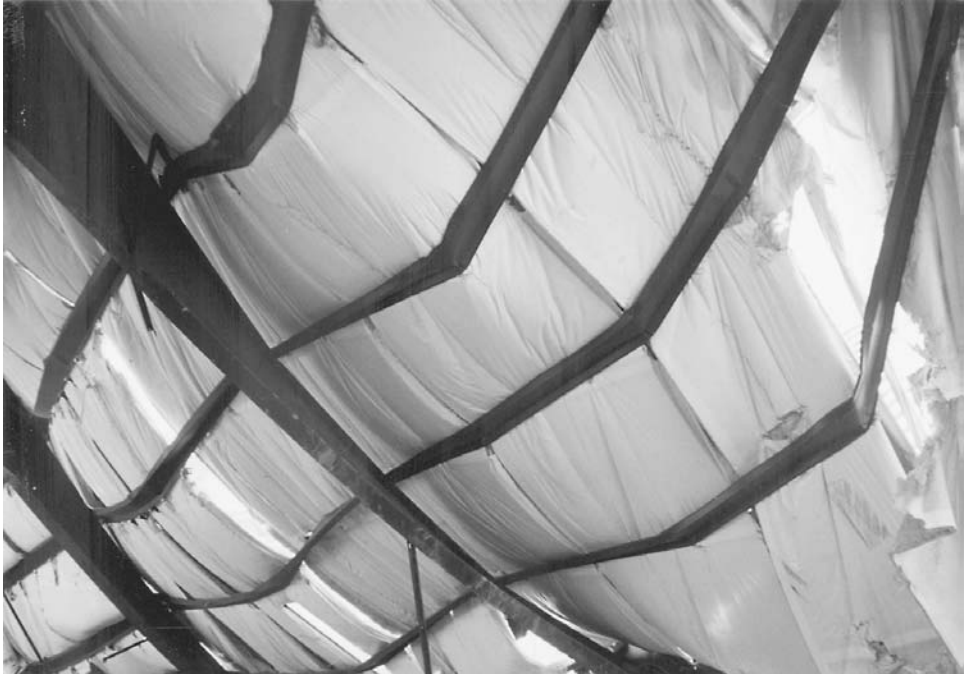
**FIGURE 10.16** Building collapse under heavy snow accumulation.

1. Overload (Fig. 10.16)
2. Improper design practices
3. Defective construction
4. Deterioration
5. Other, such as improper alterations or absence of any original design

Many failures of metal building systems can be traced to overload—a condition when more loading is imposed on the structure than it was designed to resist. For example, a building designed for a 30-psf snow load might receive a documented record snowfall of 80 psf, or a building designed to resist

80-mi/h winds gets hit with a 150-mi/h hurricane. A building collapse under either of those two scenarios could be blamed on simple overload. Indeed, even a perfectly designed and constructed building will collapse if the overload is severe enough.
