10.9.6 Failures Caused by Lack of Purlin and Girt Bracing

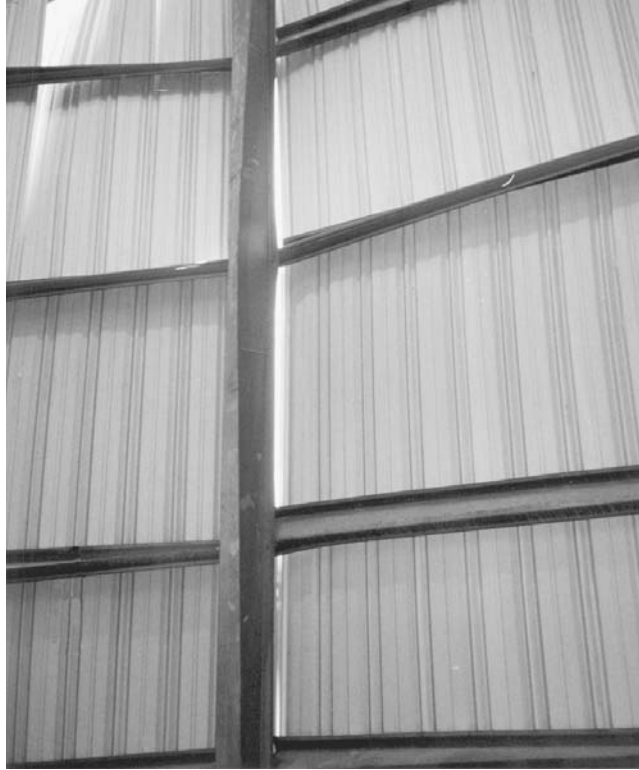
FIGURE 10.18 Buckling of laterally unbraced girts and endwall column under wind loading. (Photo: J.R. Miller & Associates.)

However, in the author's experience with investigating failures of metal buildings, properly designed purlin and girt bracing is still encountered relatively rarely. In many older buildings there is no bracing at all. Laterally unbraced girts and purlins tend to fail by the lateral-torsional buckling mode (Fig. 10.18), well before their full flexural capacity is realized. This may help explain why some pre-engineered buildings fail under heavy, but not extreme, snow and wind loading. Note that the buildings in Figs. 10.16, 10.17, and 10.18 have no discrete bracing of secondary members.
