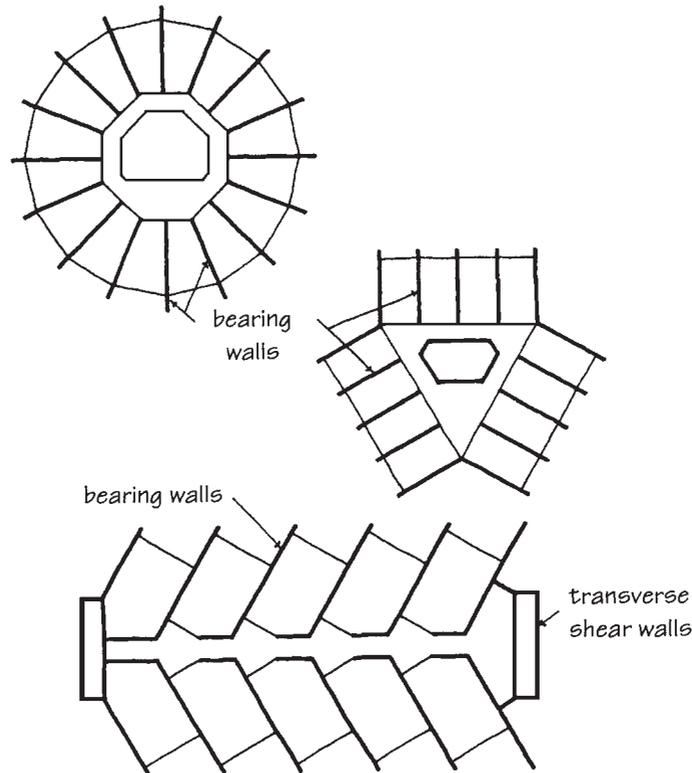
Figure 12-8 Examples of loadbearing walls oriented in multiple directions and functioning as shear walls to resist lateral loads in those directions.
