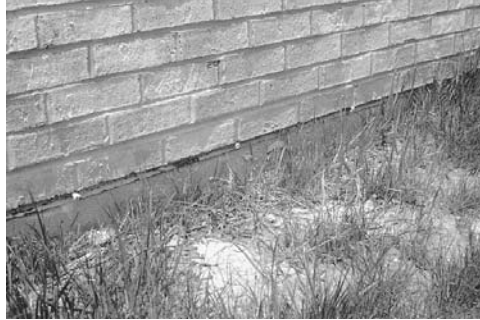
**Figure 15-35** Cotton rope wicks spaced 16 in. on center. (Photos courtesy BIA.)

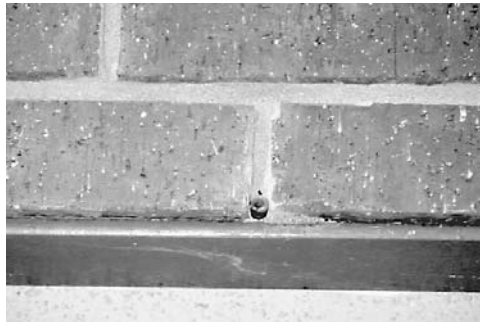
**Figure 15-36** Small plastic weep tubes are not recommended because they clog too easily both during and after construction.

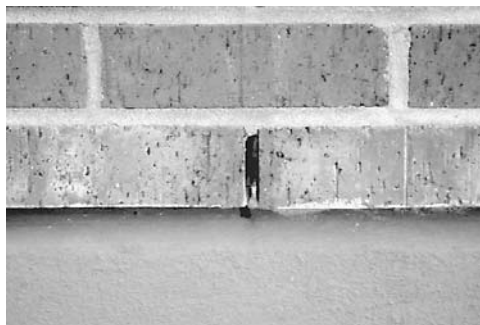
**Figure 15-37** Mortar droppings can inhibit the drainage through weeps, causing efflorescence or other moisture damage.

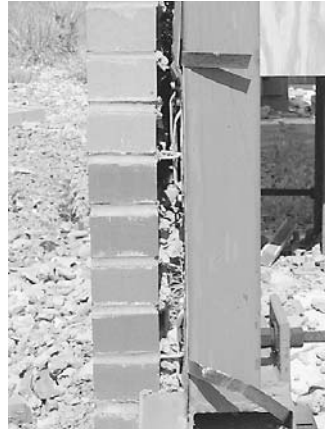
**Figure 15-38** Use of a proprietary drainage mat does not eliminate the need for proper construction procedures to minimize mortar droppings.

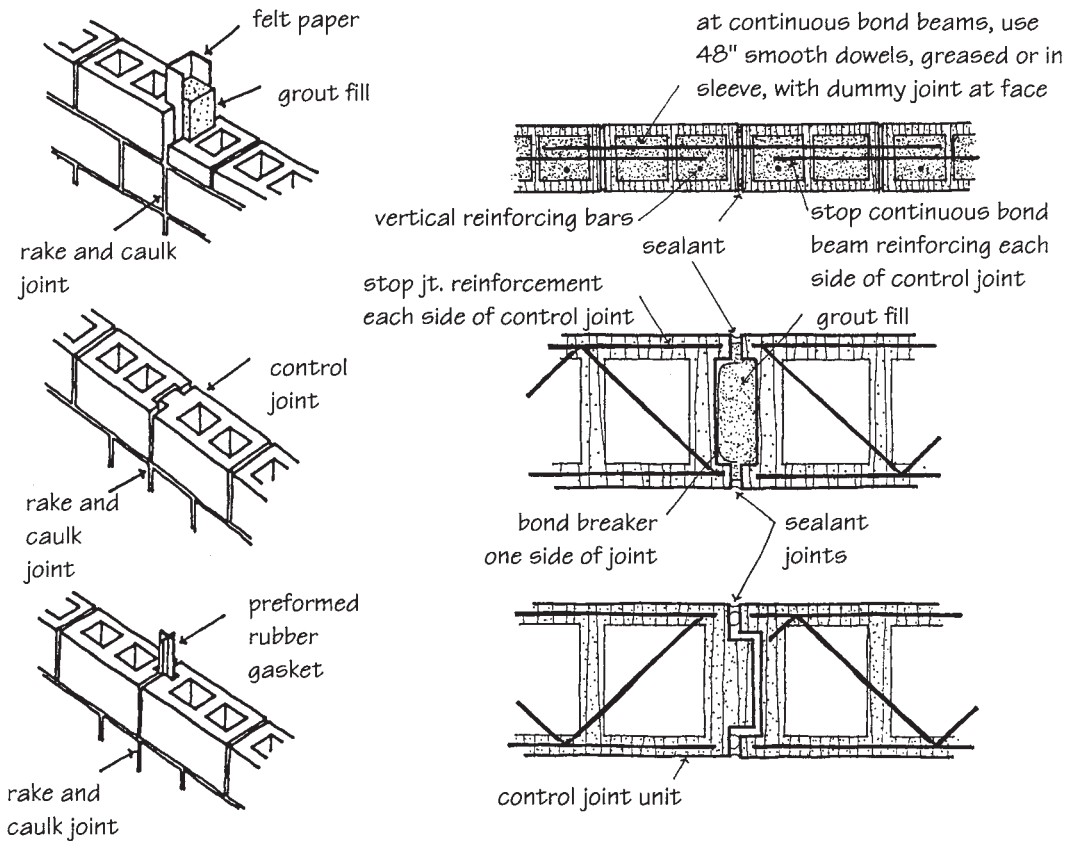
**Figure 15-39** CMU control joints.
