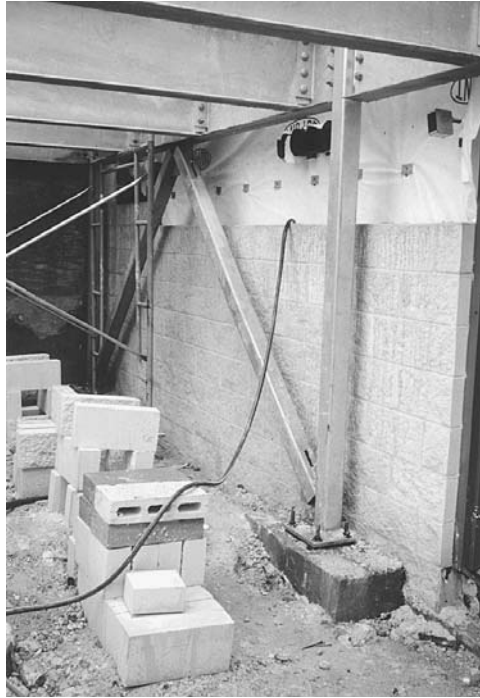
**Figure 18-3** Garden hose placed briefly in wall cavity to test for obstruction of water flow to weeps.

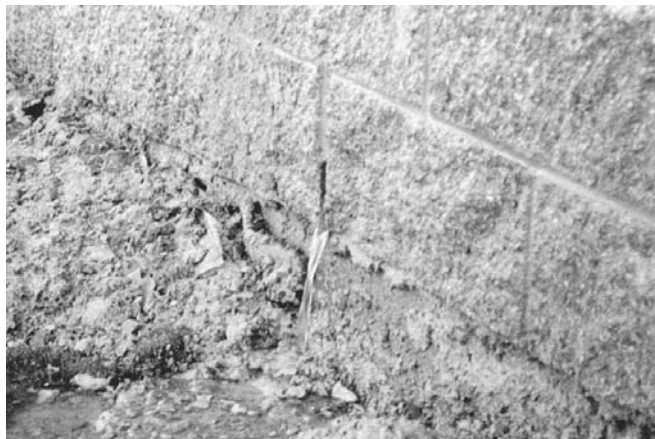
**Figure 18-4** Water should drain immediately and freely from the weep hole immediately below the test location.
