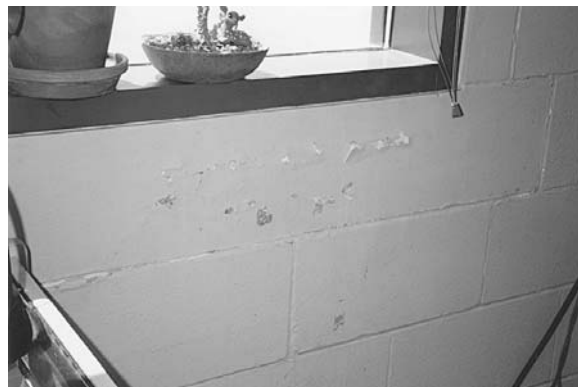
delamination of
exterior coating

delamination of
interior coating

Figure 9-57 Vapor permeance of coatings affects moisture movement through walls and can inhibit evaporation or the wall's ability to "breathe."

defective sealant joints and so on, through capillary contact with the ground, or through any number of other means. Moisture escapes from a wall in only two ways: (1) through continuous cavities with flashing and weep holes, and (2) by evaporation at the wall face (breathing). Low-permeance coatings (or a buildup of multiple coating layers) may blister or delaminate from both interior and exterior surfaces under certain circumstances (see Fig. 9-57).
