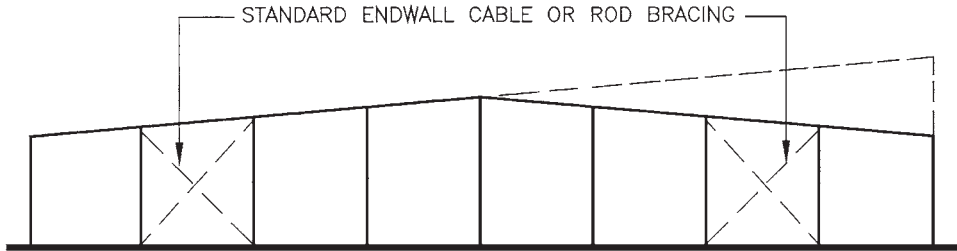
FIGURE 3.12 Typical endwall bracing locations. Buildings not exceeding 100 ft in width may need only a single set of bracing; when the width is between 100 and 240 ft, two sets are required, as shown. (*Nucor Building Systems.*)

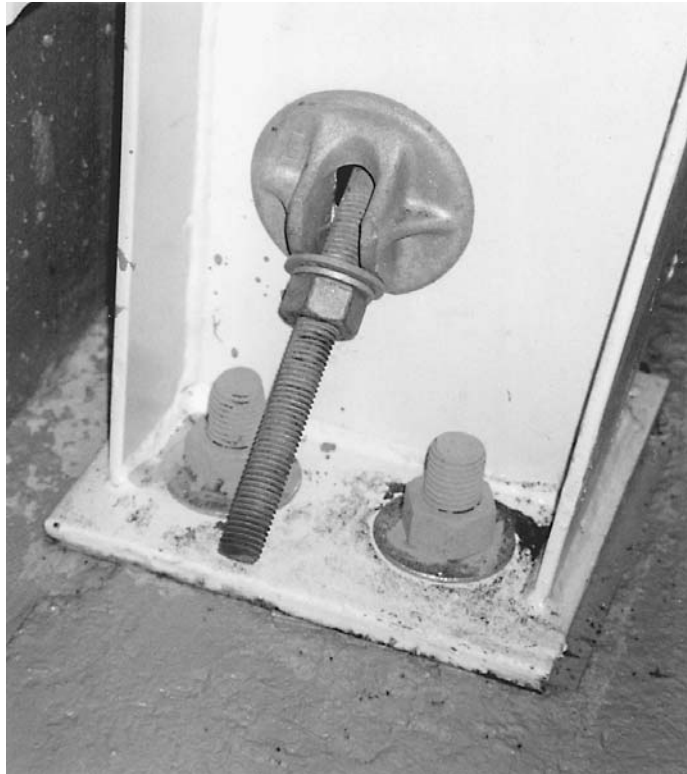
FIGURE 3.14 Hillside washer.

Failures of the hillside washer-to-web connection were reported by Miller,⁸ who investigated damage to several metal buildings from the Feb. 17, 1994, Northridge earthquake in California. He reported that five out of six such connections in one building failed. The failure mechanism involved fracture of the hillside washers (Fig. 3.15) and in some cases subsequent pull-through of the rods. The missing washer of Fig. 3.15 was located more than 15 ft away from the column.

Sinno⁹ attempted to conduct a definitive study of the ultimate behavior of the connection. His laboratory tests identified five possible failure modes, including a fracture of the rod and four failure modes in the column material and welds. Surprisingly, fracture of hillside washers documented by Miller was not among them. In any case, it seems that widespread use of standard hillside washers attached directly to thin webs should be reevaluated.
