## **16.7 SOME COMMON PROBLEMS DURING CONSTRUCTION**

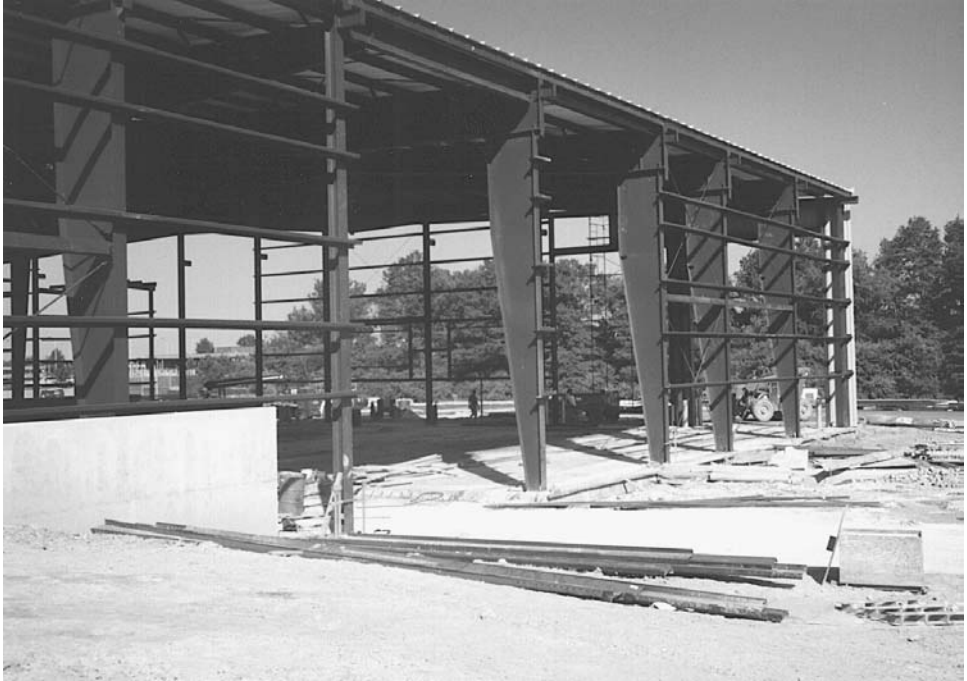
**FIGURE 16.9** The roof of this pre-engineered building is installed before the walls. (Photo: Maguire Group Inc.)
