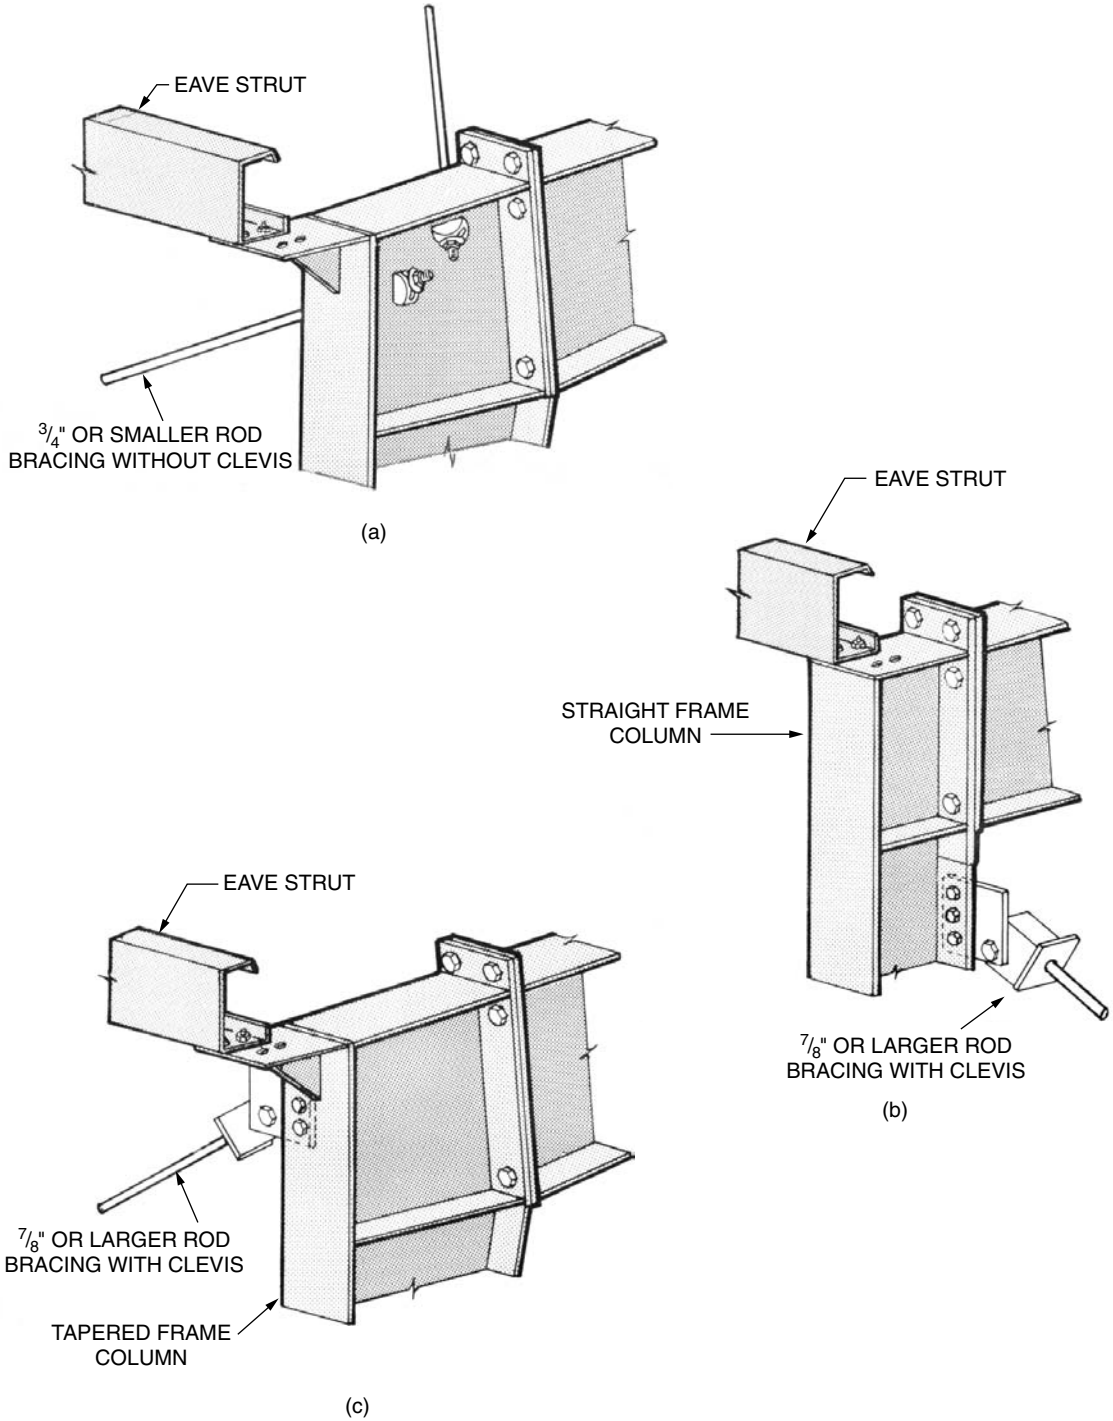
FIGURE 3.20 Various details of wall bracing attachment at the top. (Star Building Systems.)

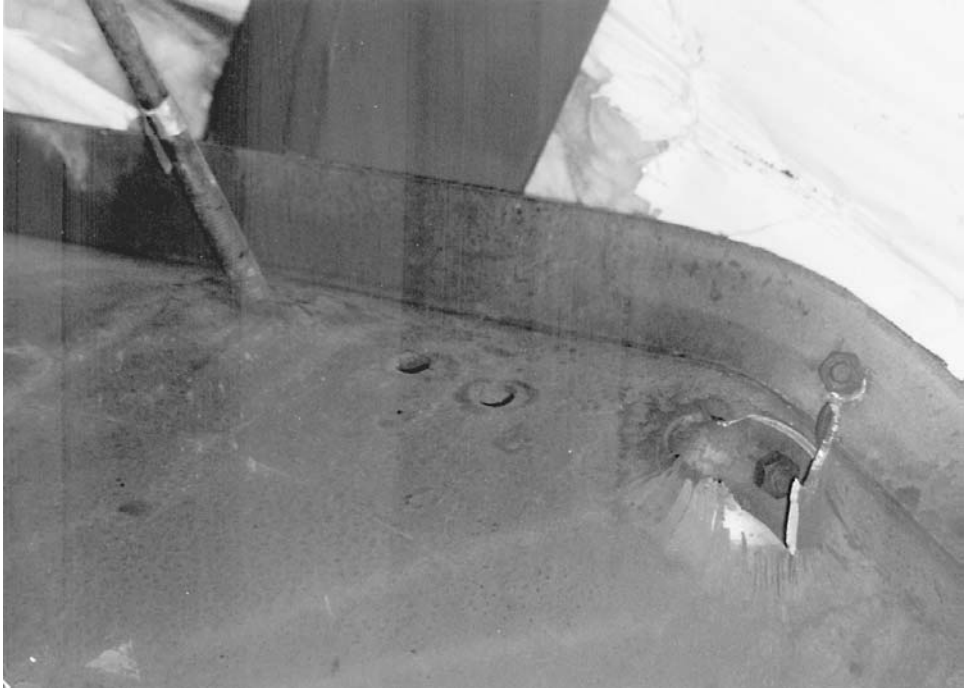
FIGURE 3.21 Fracture of the rafter web at the point of horizontal rod attachment. Note that the force applied by the bracing has also laterally displaced the rafter section.

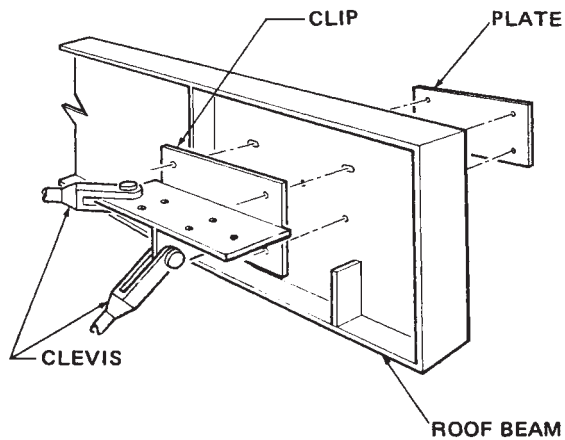
FIGURE 3.22 A bracket for load transfer between roof and wall bracing. (*Butler Manufacturing Co.*)
