### 16.7.2 Problems with Metal Superstructure

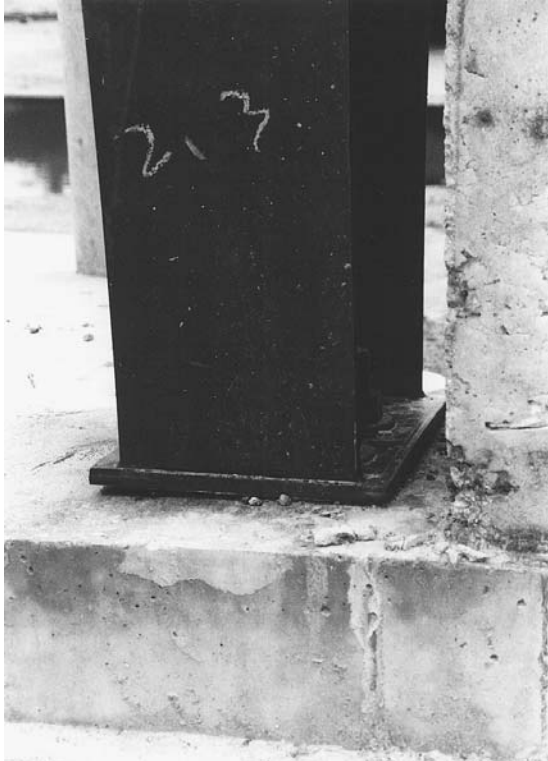
**FIGURE 16.10** A gap under the column base plate.

Not surprisingly, most of the time the pre-engineered columns, which must be plumb within MBMA tolerances, are placed directly on top of concrete piers or foundation walls that are not perfectly level. As a result, the column base plates might bear on concrete only at one edge, with a small gap under the rest of the plate (Fig. 16.10). If this gap is not filled with grout or shims, the concrete may crack or the column base may slightly deform and settle under load, causing a rattle-producing “play” between the base plate and the anchor-bolt nut above it. Base plates of building columns that support cranes, and therefore require stability and precision of installation, should always be grouted, even by the owner’s personnel if necessary.
