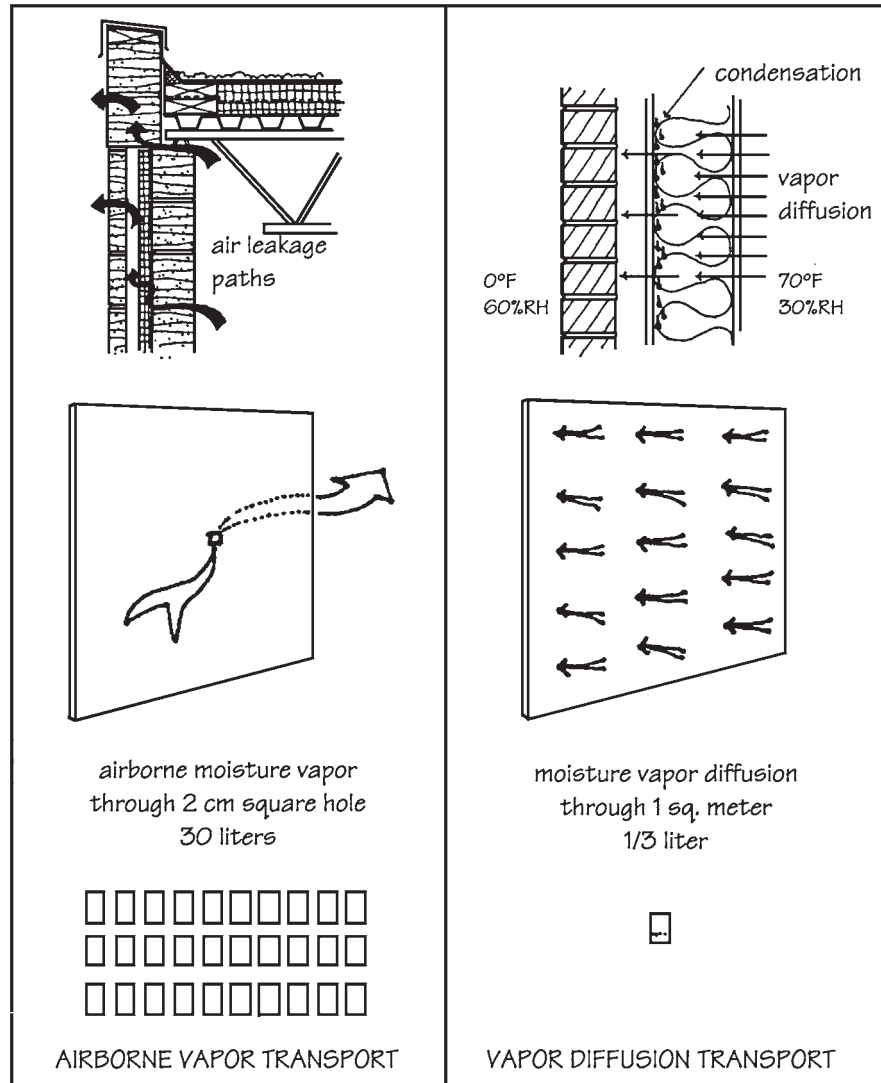
Figure 9-56 A much larger quantity of water vapor is transported through the building envelope by air leaks than by diffusion. (From R. L. Quirouette, *The Difference between a Vapor Barrier and an Air Barrier*, National Research Council of Canada, Ottawa, 1985; and Canadian Homebuilder's Association, *Builder's Manual*, CHBA, Ottawa, 1994.)

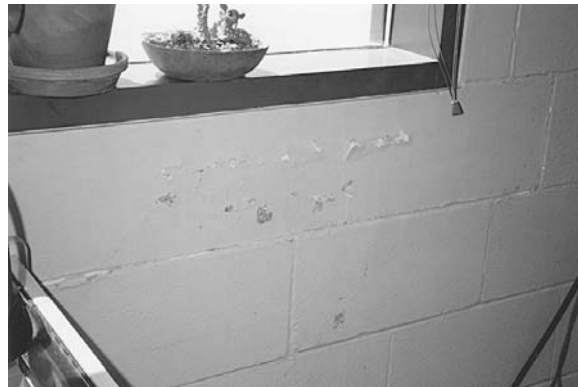
delamination of
exterior coating

delamination of
interior coating

Figure 9-57 Vapor permeance of coatings affects moisture movement through walls and can inhibit evaporation or the wall's ability to "breathe."

defective sealant joints and so on, through capillary contact with the ground, or through any number of other means. Moisture escapes from a wall in only two ways: (1) through continuous cavities with flashing and weep holes, and (2) by evaporation at the wall face (breathing). Low-permeance coatings (or a buildup of multiple coating layers) may blister or delaminate from both interior and exterior surfaces under certain circumstances (see Fig. 9-57).
