## CLIMATE ZONE 3—INTERFACE SHOWROOM

ATLANTA, GEORGIA

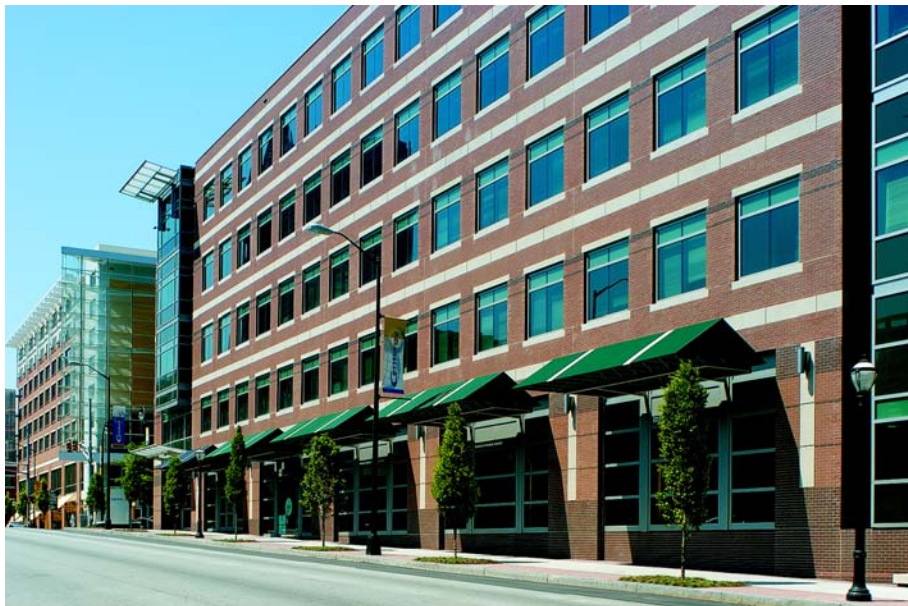
**Figure 4-3.** Interface Showroom building exterior showing first floor retail space of existing base building.

The Interface Showroom, opened to the public in 2004, is located within an urban renewal district in Midtown Atlanta, which is in climate zone 3, and includes commercial and retail space for display of carpet. It was designed and built with the goal of being designated a Platinum Project under the USGBC's LEED-CI pilot program; it did achieve that goal. As the Interface Showroom was a tenant space in a new building, upgrades to the HVAC were not possible; therefore, most energy-related sustainable initiatives focused on Cx, optimizing lighting, equipment, and appliances, measurement and verification, and green power.

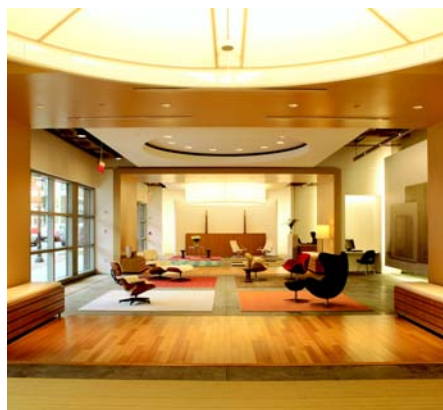
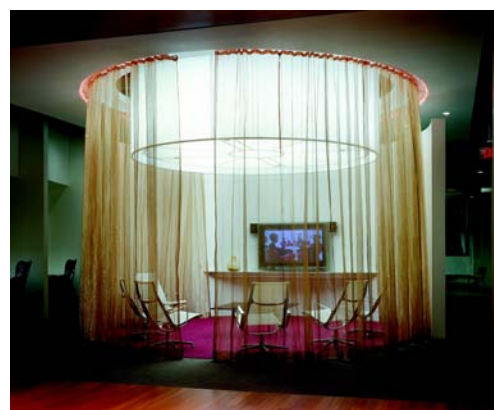
**Figure 4-4.** (a) Main entrance to retail space, which is flexible to facilitate displaying carpet under varying interior lighting conditions. (b) Area for product presentations or meetings, shown with curtains pulled to enclose the space.
