## CLIMATE ZONE 7—BIGHORN HOME IMPROVEMENT CENTER SILVERTHORNE, COLORADO

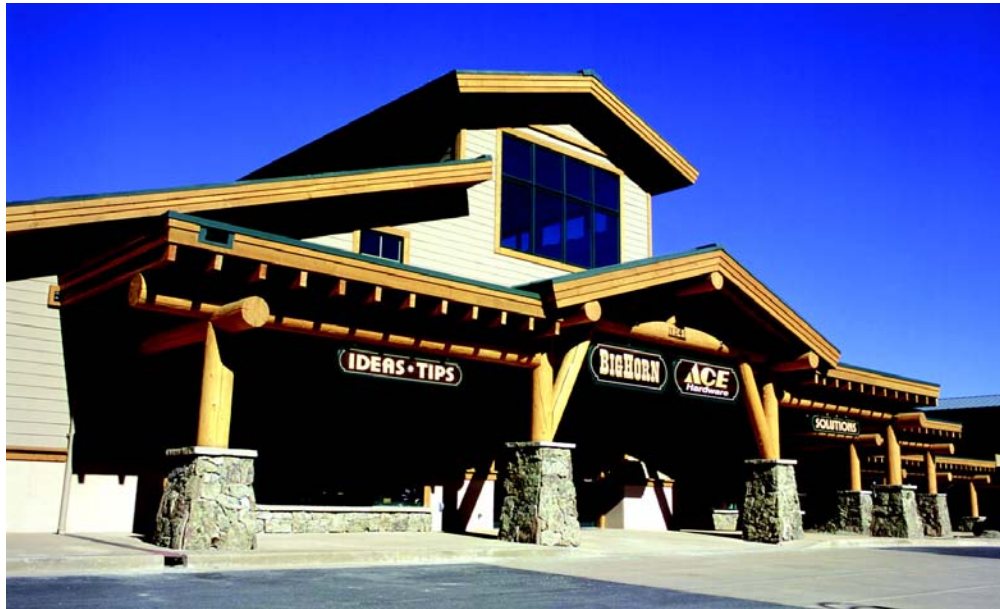
**Figure 4-13.** BigHorn Home Improvement Center entrance.

The building faces east, but the clerestory windows were designed to face north and south to best use the daylighting. The clerestories have overhangs to minimize the

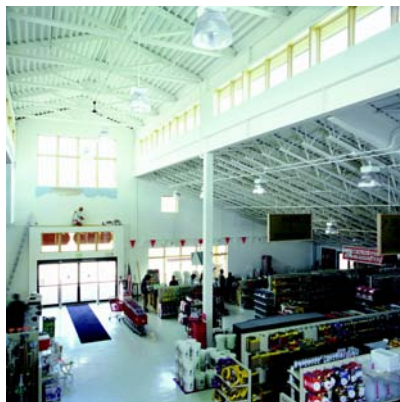
**Figure 4-14.** (a) Daylighting controls dim lights when there is enough natural light. (b) Solar panels on the roof and clerestory windows.

Energy-saving features include retail sales floor lighting designed to 1.1 W/ft<sup>2</sup>, R-38 continuous roof insulation and R-19 wall insulation with R-12.5 or R-5 continuous exterior insulation, rigid c.i. beneath the entire floor to R-10 as well as the edges, glazing with a U-value of 0.24, motion sensors for restroom and office lighting, clerestory windows to provide daylighting, and daylighting controls to “dim” lights by turning off lamps (there are five steps of lighting levels). Plug loads, including vending machines, are only energized during business hours.
