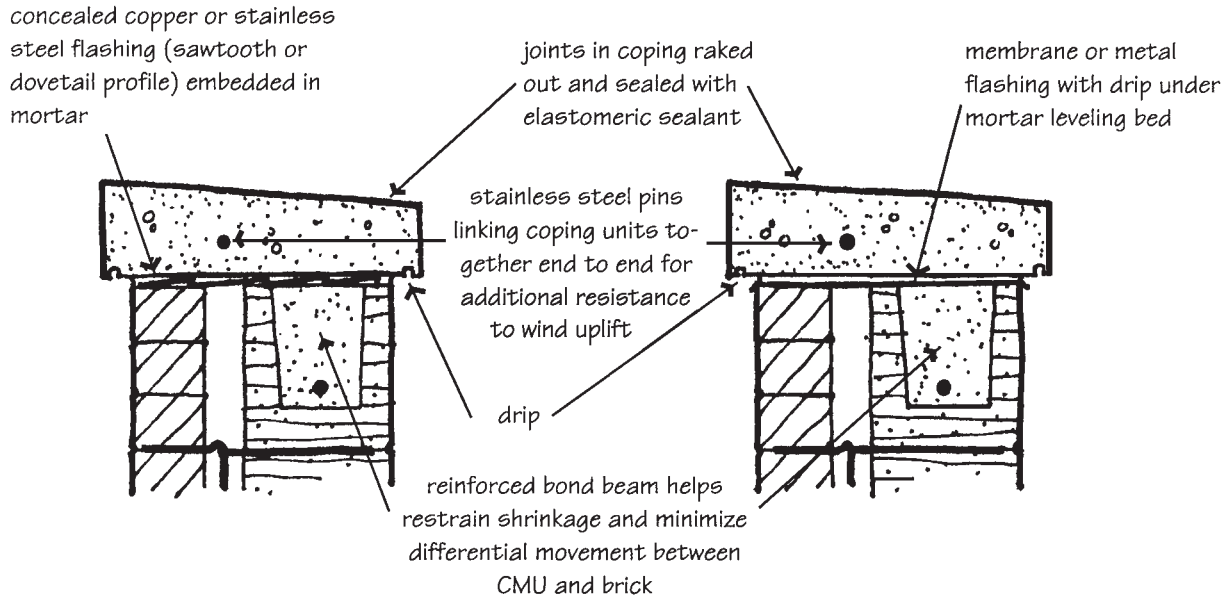
PRECAST COPING ON CAVITY WALLS

PRECAST COPING ON VENEER WALL

Figure 10-55 Cast stone parapet copings.
