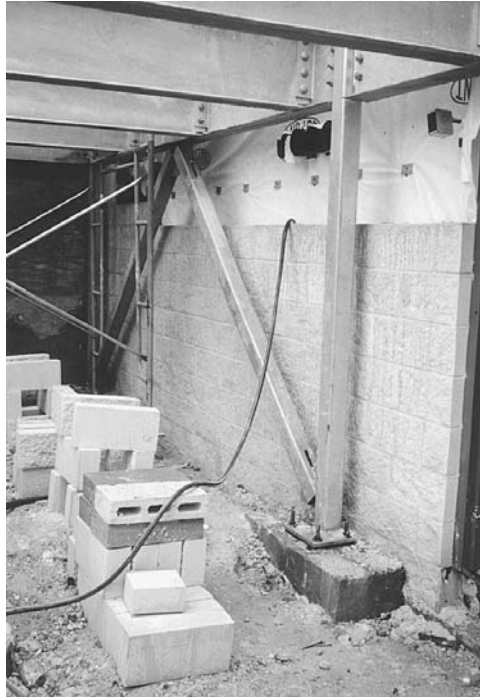
Figure 18-3 Garden hose placed briefly in wall cavity to test for obstruction of water flow to weeps.

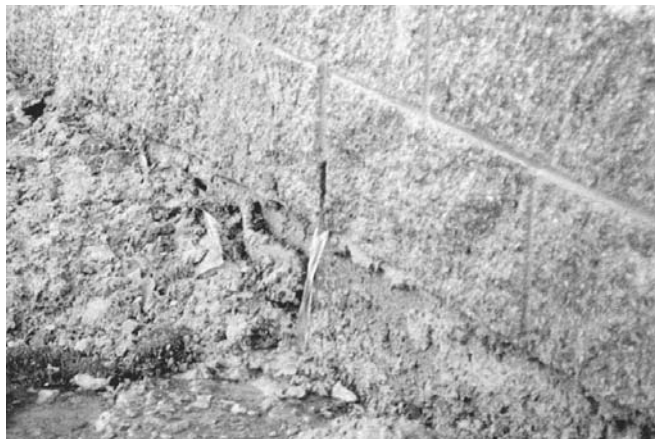
Figure 18-4 Water should drain immediately and freely from the weep hole immediately below the test location.
