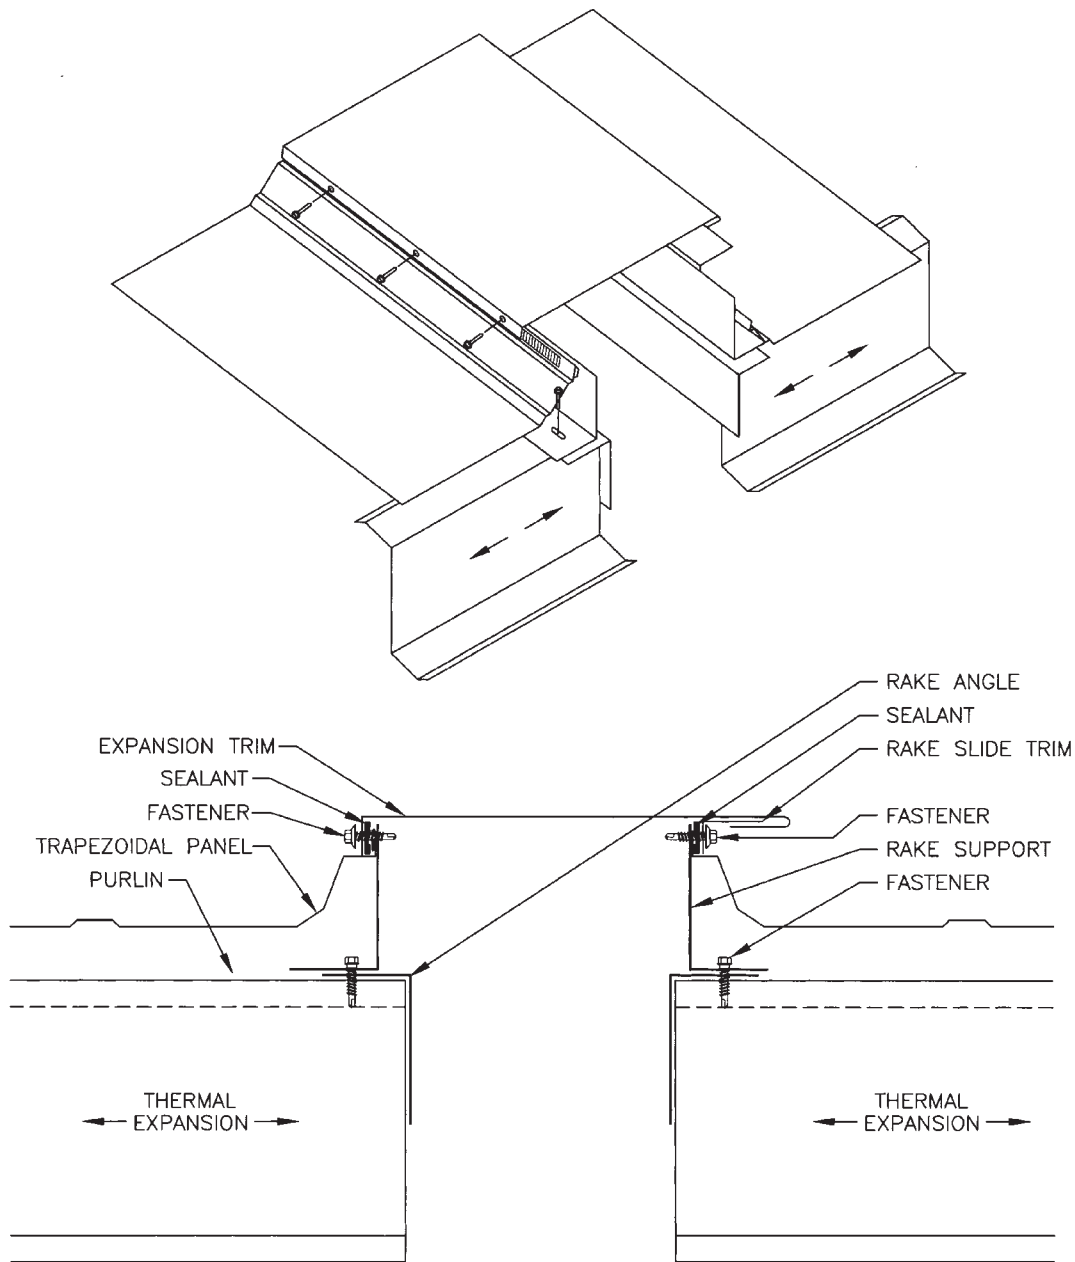
FIGURE 6.29 Details of standing-seam roofing with trapezoidal profile at building expansion joint. (MBMA.)
